Technical Report 260

**FIELD TEST OF A MESL  
(Membrane-Enveloped Soil Layer)  
ROAD SECTION IN CENTRAL ALASKA**

**July 1975**

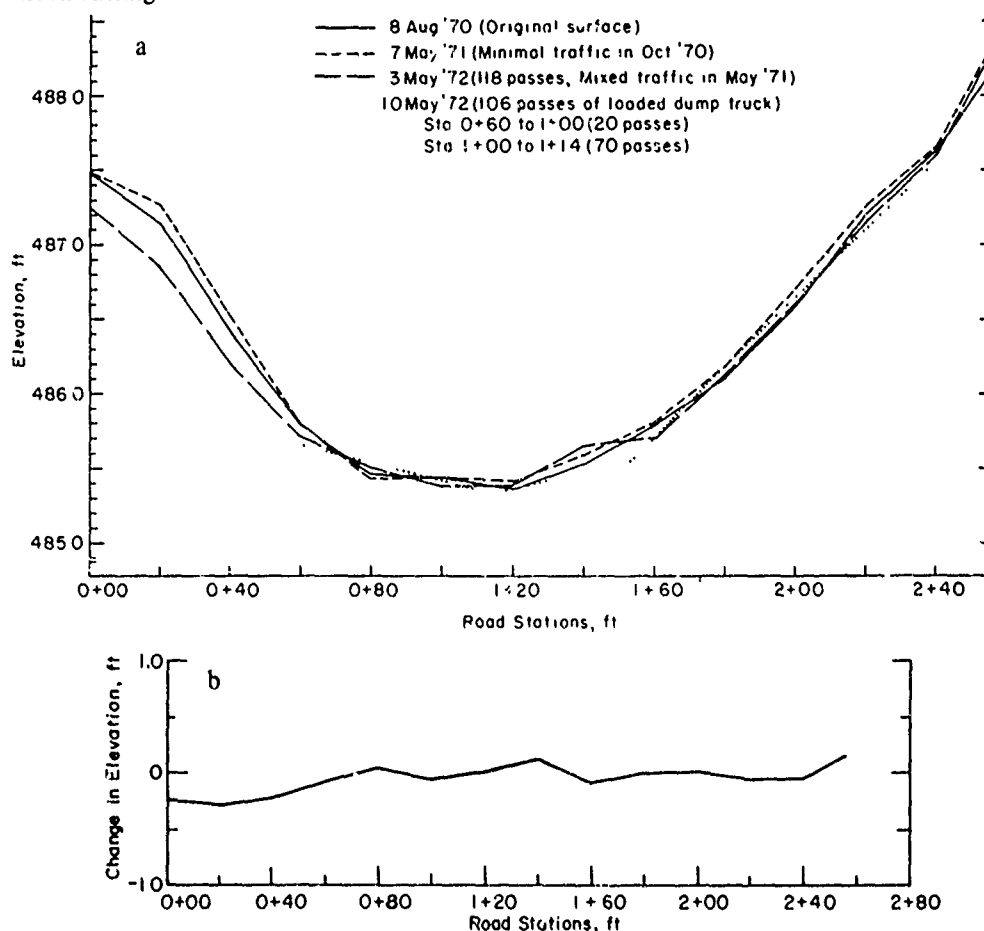
Figure 10 shows the centerline elevations of the MESL during this reporting period. The centerline elevation had changed a maximum of 2 in. along the section from station 0+60 to 2+56. No post-traffic centerline elevations were taken from stations 0+00 to 0+60, but it appears that a settlement of 3.75 in. or more had occurred in that portion of the MESL. In general the centerline had settled, except at the locations of deep wheel track rutting.

Figure 10. MESL road surface elevations and elevation changes at centerline.

Figure 10 shows the change in centerline elevation of the MESL. From the construction completion date to 3 May 1972, before the spring traffic tests were completed, the MESL elevation increased 0.17 ft at station 2+56, and settled 0.29 ft at station 0+20. These are the maximum differences in centerline elevation noted until that time. After traffic

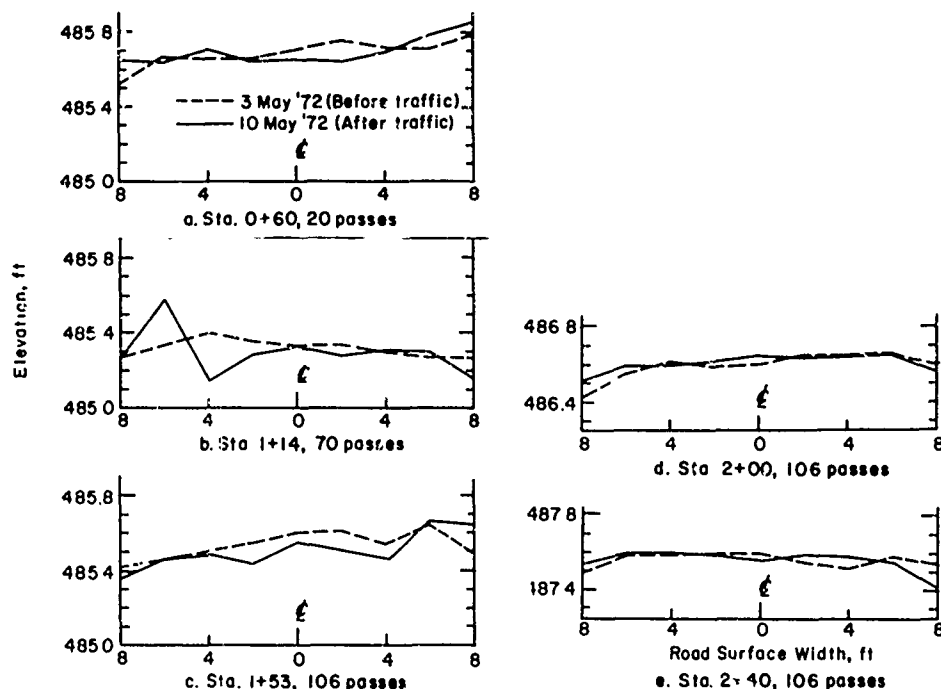
Cross-section elevations at five stations were taken before and after the May 1972 traffic testing (see Fig. 11). Station 0+60 was the location of an extensive soft spot where trafficking was limited to 20 passes; stations 1+14 and 2+40 were sites of recent CBR tests; station 1+53 appeared to have a separation of the lap seal in progress; and station 2+00 was chosen as a representative portion of the best part of the MESL test road. The cross sections generally show that the northern end of the road experienced less surface distress than the southern and middle sections during the traffic tests. These data for Figures 10 and 11 are listed in Tables III and IV, respectively.

Figure 11. MESL road surface (cross section) elevations, before and after test traffic, May 1972.

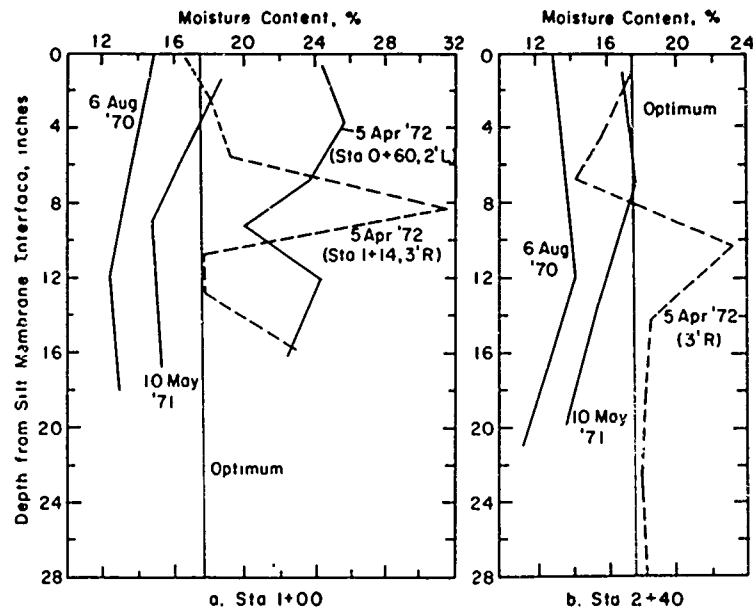
Figure 12. Moisture content in MESL at centerline. Optimum moisture content (17.5%) is from the CE-12 compaction test.

Since both the increase in moisture content (see Fig. 12) and the rutting in the middle part of the MESL were excessive, this portion of the section is considered to have failed after two freezing and thawing seasons with the indicated trafficking. In contrast, the northern part of the MESL, from stations 1+60 to 2+56, is not significantly rutted, although the moisture content has increased to an average of 21%, and this portion can be considered in satisfactory, serviceable condition. The results of the latest Benkleman beam tests (Table II) also indicate the relatively better condition of the northern portion of the MESL section.

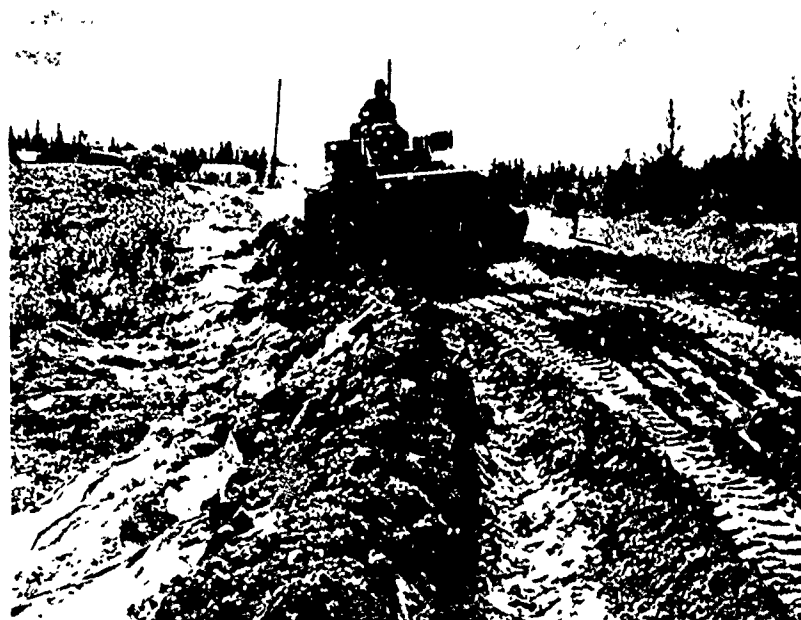
*Figure A29. Removing water-saturated silt from right side.*

In July 1971, the water-saturated silt near the tear was removed and replaced with silt from the original source having a moisture content below optimum (see Fig. A28-A30). After compaction of the new silt, the old surface membrane was put back in place and patched with new membrane and CRS-2 asphalt emulsion. The part of the MESL section affected by this repair was approximately from station 0+30 to station 1+40 from the right edge to 3 ft left of center.

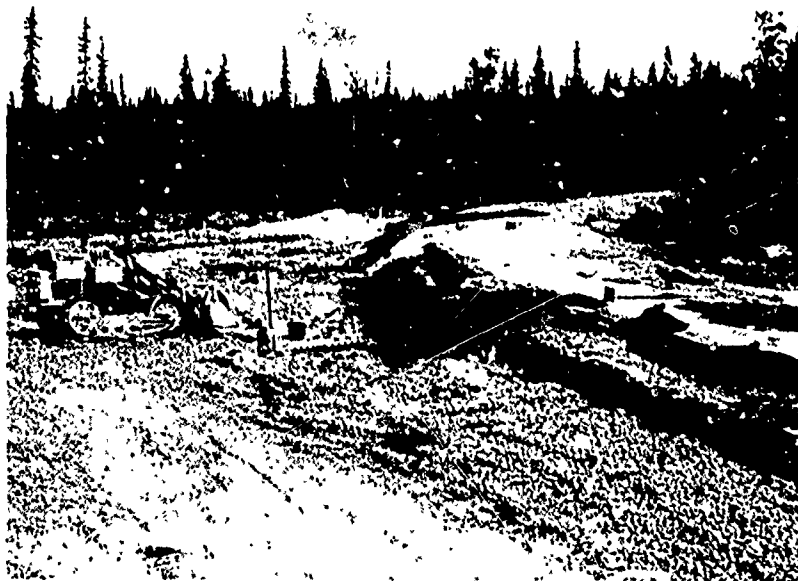
*Figure A32 Making repairs on damagea left side slope.*
